BRAKTOOTH: Causing Havoc on Bluetooth Link Manager

VULNERABILITY DISCLOSURE REPORT

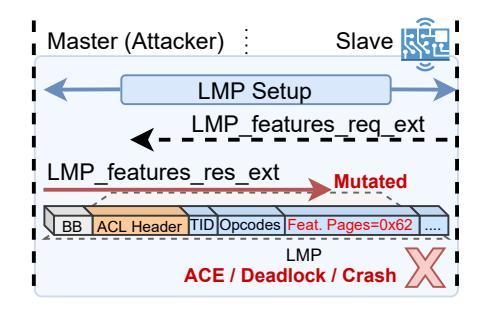
Figure 6: Feature Page Execution

The Bluetooth Classic implementation in Espressif ESP-IDF 4.4 and earlier [9] does not properly restrict the Feature Page upon reception of an LMP Feature Response Extended packet, allowing attackers in radio range to trigger arbitrary code execution (ACE) in ESP32 via a crafted Extended Features bitfield payload. As shown in Figure 6, the ACE vulnerability is triggered by simply sending *LMP_feature_res_ext* with an invalid feature page of 0x62 after *LMP Setup* procedure (c.f., Figure 1). Moreover, the contents of extended features in the *LMP_feature_res_ext* can be used to execute code at an arbitrary address within the ESP32 firmware. For example, as described in Section 4.1, such an address may point to the erase function (*nvs_flash_erase*) and disabling Wi-Fi (*disable_wifi_agc*), among others.

Impact: The attacker is able to execute arbitrary functions implemented in the target ESP32's firmware. Once the attacker acquires a dump of ESP32 firmware and the memory layout is known, functions at arbitrary addresses can be called. This allows the attacker to erase user data (NVRAM), call I/O functions that may control actuators, etc. Triggering firmware crashes or a BT deadlock is also possible during repeated attack attempts by executing invalid function addresses. In case of a deadlock, the user needs to manually reset ESP32 to restore BT communications.

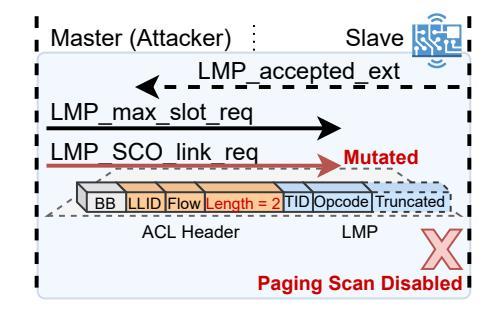
Figure 7: Truncated SCO Link Request

a power cycle (restart) of the device to restore BT communication. Following Figure 7, the attack can be launched by sending an *LMP_SCO_Link_Request* with *ACL length=2* instead of its normal size of 7.

Impact: The attacker is able to prevent external parties to connect to the device, requiring the user to manually perform a power cycle on the device to resume normal connectivity. Attack risk is reduced if the user is already connected to AC6366C or similar chipsets that only allow one active BT connection at a time.

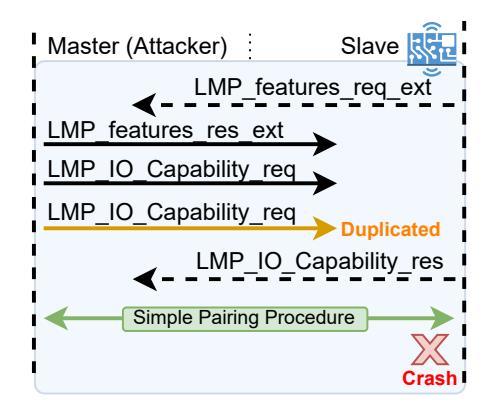
Figure 8: Duplicated IOCAP

Impact: The attacker can exploit this vulnerability to promptly cause firmware crashes and therefore maintain a DoS while the attack is taking place. Since ESP32 restarts its firmware by default upon receiving a fault, no user interaction is needed to restore BT communication after the attack is stopped.

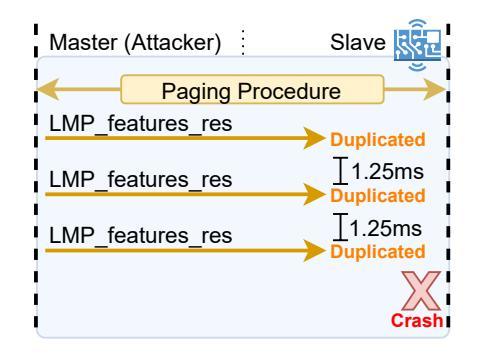
Figure 9: Feature Response Flooding

The Bluetooth Classic implementation in Espressif ESP-IDF 4.4 and earlier [9] does not properly handle the reception of continuous unsolicited LMP responses. This allows attackers in radio range to trigger a denial of service (crash) in ESP32 by flooding the target device with LMP Feature Response

data. As shown in Figure 9, *LMP_features_res* packets are sent within a BT transmission slot of 1.25ms, which effectively floods the Slave with unsolicited responses. This attack vector is also effective against a range of other BT chipsets such as **JBL TUNE500BT** [21] and **Xiaomi MDZ-36-DB** (Actions Semi. ATS2815) [39, 42]. See Table 2 for all the targets affected by V4.

Impact: The attack triggers a firmware crash on ESP32 and a shutdown on **JBL TUNE500BT** and **Xiaomi MDZ-36-DB**. In the case of a shutdown, the user needs to manually power on the device again to restore communication. Furthermore, since all targets accept multiple BT connections, the attack can also be triggered while the target is already connected to another device. For example, it is possible to immediately stop audio from playing on JBL TUNE500BT and Xiaomi MDZ-36-DB. The attacker, however, needs to know the BDAddress of the target to launch the attack.

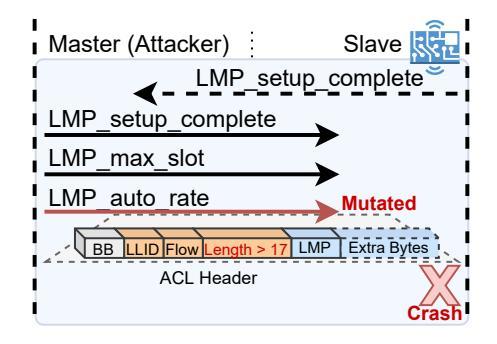
Figure 10: LMP Auto Rate Overflow

bytes, allowing attackers in radio range to trigger a crash in WT32i [24] via a crafted LMP packet. As shown in Figure 10, the attack is triggered by sending an LMP with an ACL size higher than 17 bytes. Normally this is not allowed by the BT Core Specification [31], but ESP32 radio can indeed send such oversized LMP packets over the DM1 transport channel. Our proof of concept (PoC) firmware bypasses some length checks on the transmission path to make this possible. This attack vector also works on some **Jieli AC6905X (BT Audio Receiver)**. Note that this attack requires sending this malformed packet many times over many reconnections to trigger a firmware crash. Particularly, a firmware crash on WT32i may take around 3-5 minutes to be triggered.

Impact: The attack causes a firmware crash on both **WT32i** and **AC6905X**. This can be used to cause a sporadic denial of service (DoS) attacks on such devices.

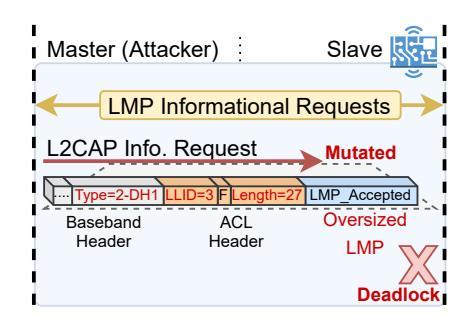
Figure 11: LMP 2-DH1 Overflow

The Bluetooth Classic implementation on Laird CSR8811 A08 [28] and CSR8510 A10 [27] SoCs allows an LMP length overflow over 2-DH1, resulting in a Deadlock (state machine or packet handler corruption) outcome. Figure 11 captures the sequence of messages exchanged to expose this vulnerability. In particular, the attack is performed by changing the transport type of the normal LMP packet to 2-DH1 and then adding more bytes to the LMP payload. This, for example, results in a total ACL length of 27.

Impact: The attack causes a BT deadlock on Laird CSR8811 and a firmware crash on CSR8510 operating as a standard BT dongle. While the dongle firmware crash is automatically recovered by the OS, the deadlock requires the user to perform a power cycle to restore normal BT communication. The attack does not affect Bluetooth Low Energy (BLE) communication in CSR8811.

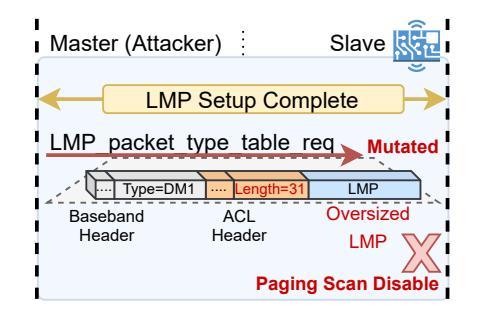
Figure 12: LMP DM1 Overflow

The Bluetooth Classic implementation on Bluetrum AB5301A [5] (tested with AB32VG1 dev. kit [4]) with unspecified firmware versions does not properly handle the reception of oversized DM1 LMP packets. This allows attackers in radio range to prevent new BT connections (disabling the AB5301A inquiry and page scan procedures) via a crafted LMP packet. Following Figure 12, an arbitrary LMP packet (LMP packet type table req) is sent with an ACL length of 31, which is much higher than the expected 17 byte limit for DM1 transport. Due to a lack of check of DM1 length, an undefined behaviour on the target baseband implementation was observed. This eventually disables the paging scan procedure and hence blocks new connections. If the user is already connected to AB5301A and the attack is started (multiple BT connections are allowed), the active connection is not disrupted, but new connections or reconnection is not possible. As compared to V5 (Section 8.5), this attack works with any overflown LMP packet rather than a specific LMP packet.

Impact: The impact of this attack is similar to **V2** (Section 8.2), in which connections to the target are not accepted due to the page scan procedure being disabled after the attack (see Figure 1). Therefore, the user needs to manually perform a power cycle (restart) of the device to restore normal BT connectivity.

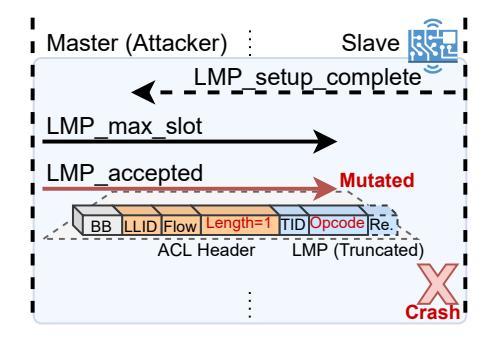
Figure 13: Truncated LMP Accepted

As the BT implementation of the target is closed source, the exact root cause of this vulnerability is not known. However, it is common that LMP procedures involving slot and rate adjustments are usually implemented in an interrupt handler different than other non-real-time LMP packets, such as feature requests and version requests. Such a handler may miss some checks which are present on the other handlers, explaining why some overflow/underflow attacks only work for certain LMP packet opcodes. This split in the LMP handler is present, for instance, in ESP32 BT implementation.

Impact: The impact is a denial of service due to a firmware crash & restart. The overall risk of such an attack is reduced if AC690X and AC692X do not allow multiple BT connections. In such a scenario, the attacker could only trigger a firmware crash when no user is connected to AC690X or AC692X.

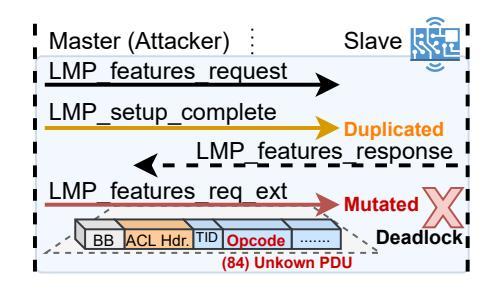
Figure 14: Invalid Setup Complete

This scenario is illustrated in Figure 14. The attacker sends an unexpected (duplicated) *LMP_setup_complete*, followed by a malformed *LMP_features_req_ext* with an invalid LMP opcode such as 0x64. The behaviour seen in Figure 14 allows attackers in radio range to deadlock a device via injecting crafted LMP packets. Moreover, the user needs to manually reboot the device to restore communication.

Impact: An attacker can exploit this vulnerability to perform a DoS. The overall risk of such an attack is reduced if AC690X and AC692X do not allow multiple BT connections.

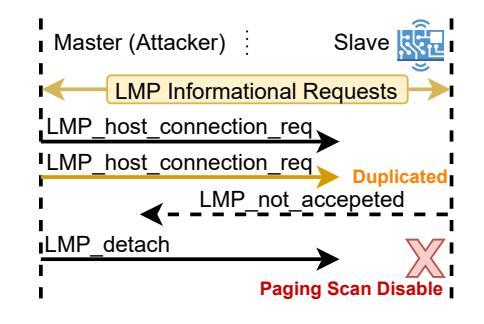
Figure 15: Host Connection Flooding

The Bluetooth Classic implementation on Actions ATS2815/ATS2819 [39] chipsets does not properly handle the reception of multiple *LMP_host_connection_req* as shown in Figure 15. This allows attackers in radio range to trigger a denial of service (deadlock) if no user is connected to the target. Manual user intervention is required to restart the device and restore Bluetooth communication.

Impact: An attacker in radio range can exploit the vulnerability to perform DoS and shutdown or restart products using chipsets and products based on Actions ATS2815/ATS2819. However, the impact of the attack is reduced as the vulnerability is only exploited when no other user device is connected to the target.

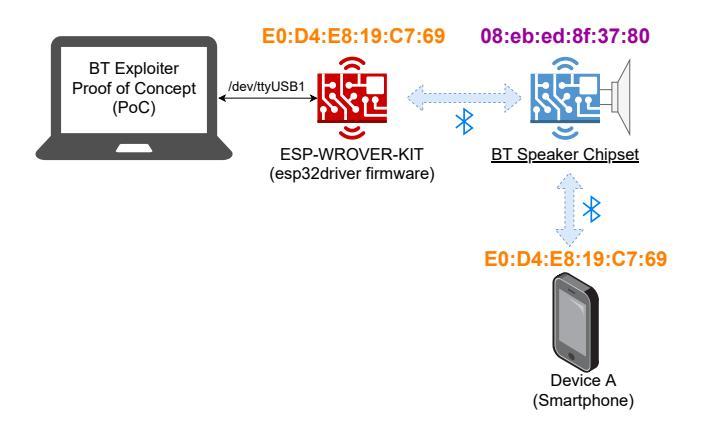
Figure 16: Same Host Connection

When reaching Actions Semi during the disclosure period, the company has informed us that they recommend the product vendors to only allow one audio BT connection. However, when we tested an ATS chipset based product *Xiaomi MDZ-36-DB*, we observed that multiple BT connections are allowed, albeit only one device can play audio at a time. Normally, connections with repeated host BDAddress are rejected on *LMP Setup* procedure (c.f., Figure 1). However, this procedure is successful when testing *Xiaomi MDZ-36-DB* with repeated host BDAddress, leading the audio device to an undefined state.

Impact: An attacker in radio range can exploit this vulnerable behaviour to perform DoS and intentionally deadlock the target device.

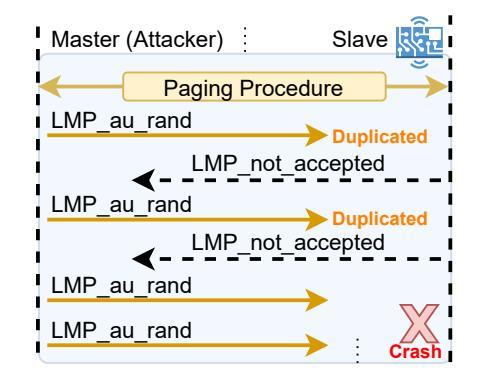
Figure 17: LMP AU Rand Flooding

Many major chipset vendors are affected by this attack as shown in Table 2. This attack is similar to Feature Response Flooding (Section 8.4), indicating that flooding testing with packets from certain LMP procedures may not have been well tested. This may arise because the *Core Specifications* only allows a limited LMP testing mode [32] that restricts the SoC to work with only a few LMP packets. This, in turn, may restrict the test flexibility for BT vendors. Specifically, vendors may have a limited capacity of tests that they can perform with their production BT firmware, such as flooding or sending out-of-order packets during normal LMP procedures.

Impact: An attacker in radio range can exploit this vulnerable behaviour to perform DoS and intentionally crash or deadlock the target device.

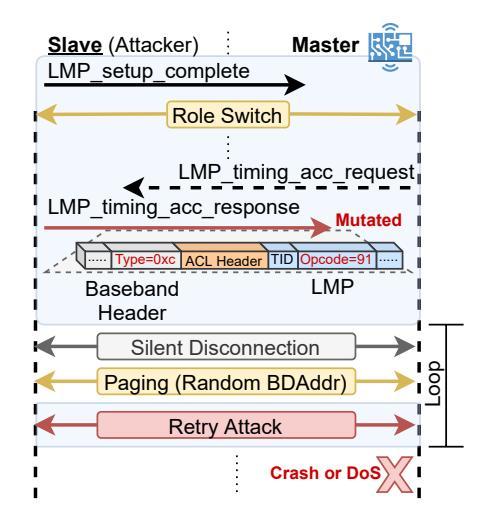
Figure 20: Invalid Timing Accuracy

The first DoS (Invalid Timing Accuracy - 8.14) is due to a failure in the SoC to free resources upon receiving an invalid LMP_timing_accuracy_response from a BT slave. The attacker can exhaust the SoC by (a) paging, (b) sending the malformed packet, and (c) disconnecting without sending LMP_detach. These steps are repeated with a different BT address (i.e., BDAddress) until the SoC is exhausted from accepting new connections. On exhaustion, the SoC fails to recover itself and disrupts current active connections, triggering firmware crashes sporadically. This vulnerability allows an attacker to forcibly disconnect slave BT devices currently connected to AX200 under Windows or Linux Laptops. Similarly, Android phones such as Pocophone F1 and Oppo Reno 5G [26] experience BT disruptions. For example, users connected to BT Headsets experience audio to be continuously "cut" during the attack. This also results in firmware crashes and restart of Android BT Service. In all cases, the OS tries to recover connectivity which can be continuously disrupted.

Impact: This attack causes a denial of service (DoS) attack. Specifically, while the attack is in progress, the target devices are unable to use the Bluetooth service normally.

The impact of this attack does not persist after the attack stops. This is because the target normally tries to recover the BT connection by performing a re-connection to previously disconnected devices (e.g., Intel AX200 under Linux or Windows). In the case of a WCN3990 firmware crash, the Android OS restarts the Bluetooth daemon and re-uploads a firmware image to WCN3990. Finally, for CYW20735B1, it restarts automatically upon any fault due to its watchdog timer being enabled by default. Nevertheless, in all cases, it is not possible to normally use the device while the attack is in progress, as the BT connection can be disrupted continuously. The attacker only needs to know the BDAddress of the target device and no authentication is required to launch the attack.

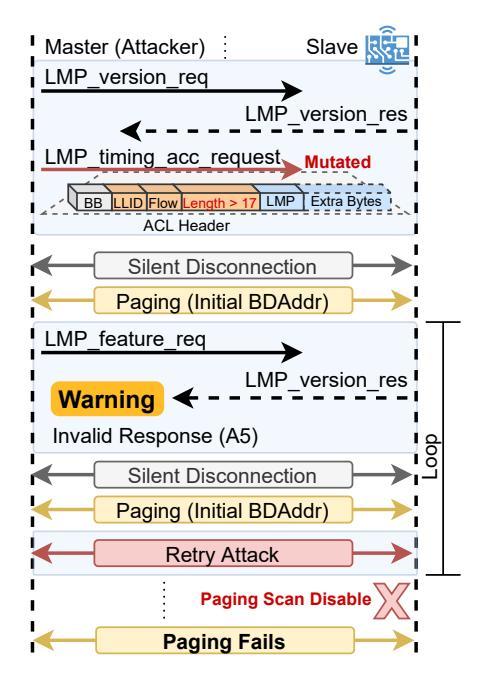
Figure 21: Paging Scan Disable

The second DoS (**Paging Scan Disable** - 8.16) affects only devices using Intel *AX200* and it is triggered when an oversized *LMP_timing_accuracy_request* (>17 bytes) is sent to *AX200 slave*. This temporarily corrupts *AX200* firmware, which responds incorrectly during a subsequent BT connection and eventually disables the *paging scan* procedure (cf., Figure 1). Thus, scanning *AX200* works, but no connection is established from an external BT device. Therefore, this attack can be used to trick an user to connect to the attacker's BT hardware instead of the legitimate target since **AX200** paging scan is disabled. Indeed, the user needs to manually re-enable BT to restore functionality. The attack is also used to disconnect certain *master* BT devices connected to a vulnerable Laptop. This leads to sporadic BT firmware crashes.

Impact: Once the attack is triggered and successful, the attacker can cause DoS via the following **AX200** behaviours: (I) paging scan is disabled, which prevents any external device to connect to the target even if the BDAddress is known. This behaviour can be used to trick an user to connect to the attacker's BT hardware instead of the legitimate target since **AX200** paging scan is disabled; (II) Multiple active BT connections cannot be performed from the target. The user requires to manually restart the Bluetooth service to restore normal BT behaviour. On Linux and Windows, BT is recovered by disabling and enabling Bluetooth via their respective configuration menu.

Firmware crashes may be sporadically triggered on **AX200** during the attacks, but no specific scenario was found to reliably trigger such crashes all the time.
