BRAKTOOTH: Causing Havoc on Bluetooth Link Manager

VULNERABILITY DISCLOSURE REPORT

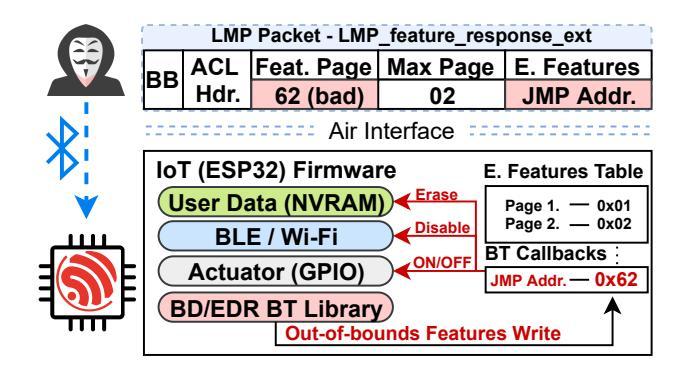
The most critical vulnerability (V1 in Table 2 - 8.1) affects ESP32 SoC [37], which is used in many Wi-Fi and Bluetooth IoT appliances such as Industry Automation, Smart Home, Fitness, etc. The attack is illustrated in Figure 3. A lack of out-of-bounds check in ESP32 BT Library [11] allows the reception of a mutated LMP_feature_response_ext. This results in the injection of eight bytes of arbitrary data outside the bounds of Extended Feature Page Table ("E. Features Table" in Figure 3). An attacker, which knows the firmware layout of a target device, can write a known function address (JMP Addr.) to the offset pointed by Features Page ("Feat. Page" in the LMP_feature_response_ext packet) field. It turns out that the BT Library stores some callback pointers within the outof-bounds Features Page offset and such a callback is eventually invoked during the BT connection. While exploiting this vulnerability, we forced ESP32 into erasing its NVRAM data (normally written during product manufacturing) by setting JMP Addr. to the address of nvs_flash_erase. Such erase function is always included in ESP32 SDK [9] and therefore, it is present in any ESP32 firmware. Similarly, disabling BT or BLE can be done via *esp_bt_controller_disable* and Wi-Fi via *disable_wifi_agc*. Additionally, general-purpose input/output (GPIO) can be controlled if the attacker knows addresses to functions controlling actuators attached to ESP32. As expected, this has serious implications if such an attack is applied to Bluetooth-enabled Smart Home products.

Figure 3: An Illustration of CVE-2021-28138.

The Bluetooth Classic implementation in Espressif ESP-IDF 4.4 and earlier [9] does not properly restrict the Feature Page upon reception of an LMP Feature Response Extended packet, allowing attackers in radio range to trigger arbitrary code execution (ACE) in ESP32 via a crafted Extended Features bitfield payload. As shown in Figure 6, the ACE vulnerability is triggered by simply sending *LMP_feature_res_ext* with an invalid feature page of 0x62 after *LMP Setup* procedure (c.f., Figure 1). Moreover, the contents of extended features in the *LMP_feature_res_ext* can be used to execute code at an arbitrary address within the ESP32 firmware. For example, as described in Section 4.1, such an address may point to the erase function (*nvs_flash_erase*) and disabling Wi-Fi (*disable_wifi_agc*), among others.
