# SweynTooth: Unleashing Mayhem over Bluetooth Low Energy

Matheus E. Garbelini<sup>1</sup>; Sudipta Chattopadhyay<sup>1</sup>; Chundong Wang<sup>1</sup> <sup>1</sup>Singapore University of Technology and Design

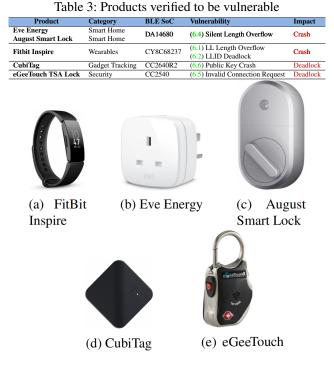
Figure 2: An illustration of some vulnerable products.

The exploitation of the vulnerabilities translates to dangerous attack vectors against many IoT products released in 2018-2019. At first glance, most of the vulnerabilities affect product's availability by allowing them to be remotely restarted, deadlocked or having their security bypassed. In order to raise awareness of the threats and risks of potentially vulnerable products already on the market, we have performed attacks on five representative IoT products which use the affected SoCs (cf. Table 2) as their main processor. These products are shown in Figure 2.

the wearable when both issues are exploited, we have sent malicious packets to the Fitbit Inspire smartwatch (Figure 2a) through the BLE communication channel.

**August Smart Lock** - We have verified that the *Silent Length Overflow* also affects the popular **August Smart Lock** (Figure 2c). Such a smart lock remotely controls access to house doors. Hence, it is advisable that users update their affected devices as soon as possible. This is to avoid a worst-case exploit, which could grant access control to a thief by means of remote execution.

- Tracking Gadget: CubiTag The *CubiTag* Bluetooth tracker is a popular product that tracks the belongings of a user (Figure 2d). When the tracker is near an object of interest, it can be found by using a mobile app, which searches for the tracker and starts an alarm on the tracker. As a result, the user can hear the alarm and find the object. However, *CubiTag* relies on a vulnerable TI CC2640R2 SDK. Out of two vulnerabilities on this SDK, only the *Public Key Crash* affects availability of CubiTag. The CubiTag immediately stops advertising its deadlocked. *The CubiTag device only works again by manually opening it with a screwdriver and re-inserting its battery*. This is for the tracker SoC to reboot properly and to establish normal BLE connection.

- Smart Locks: eGee Touch The eGee Touch, shown in Figure 2e, is a smart luggage lock that can be remotely locked or unlocked through a smartphone app. During our tests, as the device uses the TI CC2540 SoC, we could lead the smart lock in a deadlock state by exploiting the *Invalid Connection Request* vulnerability. When an attack is carried out, the device hangs and the user needs to manually press the *power on* button on the smart lock to re-interact with it. This is not a critical problem by itself. However, the worst-case scenario occurs when the user enables continuous advertisement on the smart lock. This prevents the device to automatically restart after the attack, hence its batteries must be re-inserted to reboot its processor and restore functionalities back to normal.
